# Technological and Chemical Drivers of Zinc Coating Degradation in DX51d+Z140 Cold-Formed Steel Sections

This study investigates the technological and chemical causes of early zinc-coating degradation on cold-formed steel sections produced from DX51D+Z140 galvanized coils. Commercially manufactured products exhibiting early corrosion symptoms were used in this study. The entire processing route, which included strip preparation, cold rolling, hot-dip galvanizing, passivation, multi-roll forming, storage, and transportation to customers, was analyzed with respect to the residual surface chemistry and process-related deviations that affect the coating integrity. Thirty-three specimens were examined using electromagnetic measurements of coating thickness. Statistical analysis based on the Cochran’s and Fisher’s criteria confirmed that the increased variability in zinc coating thickness is associated with a higher susceptibility to localized corrosion. Surface and chemical analysis revealed chloride contamination on the outer surface, absence of detectable Cr(VI) residues indicative of insufficient passivation, iron oxide inclusions beneath the zinc coating originating from the strip

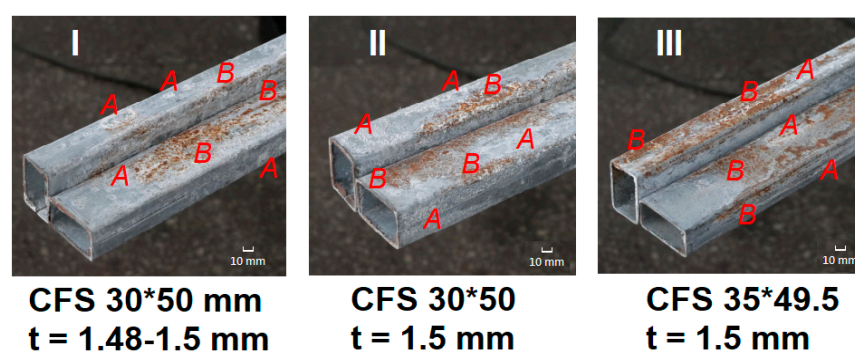
**Figure 5.** Typical corrosion marks on cold-formed galvanized steel sections of different cross-sections (I–III): representative areas with white rust products on the zinc coating (A) and localized corrosion associated with oxidation of the steel substrate (B).

4. **Corrosive damage during storage.** Marks of white rust were detected after short-term storage, predominantly in areas previously affected by mechanical microdamage.

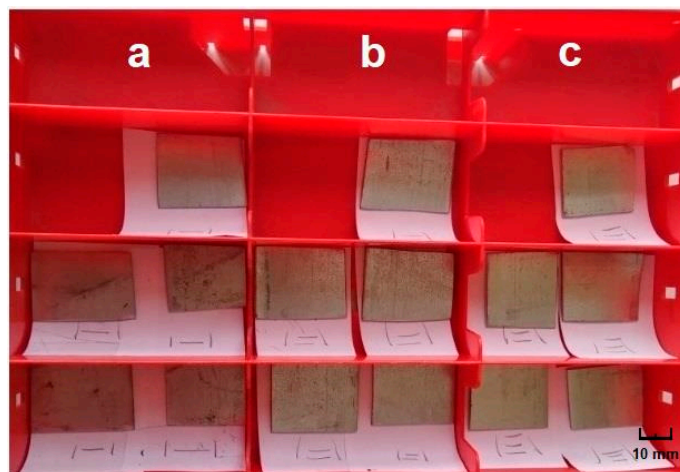
**Figure 7.** Test specimens cut from flat galvanized strip blanks prior to roll forming: (a) strip blank “Poland” (Series I); (b,c) blanks from strips (Series II) and (Series III), supplied by the same manufacturer but certified separately.

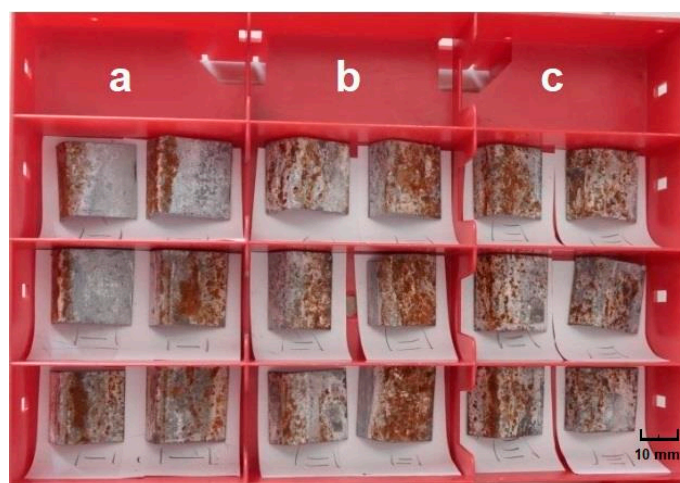
**Figure 8.** Test specimens cut from cold-formed hollow sections for chemical testing: (a) CFS (IV)— $30 \times 50$  mm,  $t = 1.48$ – $1.5$  mm; (b) CFS (V)— $30 \times 50$  mm,  $t = 1.5$  mm; (c) CFS (VI)— $35 \times 49.5$  mm,  $t = 1.5$  mm.

The examined sections were manufactured from coils of similar steel grade but with different production histories, enabling a comparative analysis of variations in technological conditions. All three CFS specimens exhibited visible signs of corrosion damage to varying degrees, including both white and brown rust.
