# Technological and Chemical Drivers of Zinc Coating Degradation in DX51d+Z140 Cold-Formed Steel Sections

This study investigates the technological and chemical causes of early zinc-coating degradation on cold-formed steel sections produced from DX51D+Z140 galvanized coils. Commercially manufactured products exhibiting early corrosion symptoms were used in this study. The entire processing route, which included strip preparation, cold rolling, hot-dip galvanizing, passivation, multi-roll forming, storage, and transportation to customers, was analyzed with respect to the residual surface chemistry and process-related deviations that affect the coating integrity. Thirty-three specimens were examined using electromagnetic measurements of coating thickness. Statistical analysis based on the Cochran’s and Fisher’s criteria confirmed that the increased variability in zinc coating thickness is associated with a higher susceptibility to localized corrosion. Surface and chemical analysis revealed chloride contamination on the outer surface, absence of detectable Cr(VI) residues indicative of insufficient passivation, iron oxide inclusions beneath the zinc coating originating from the strip

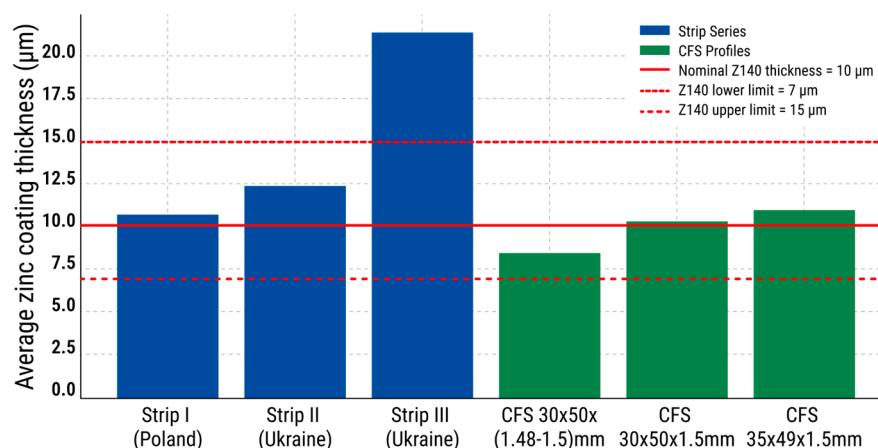
Figure 9 illustrates the average zinc coating thickness for all tested specimens in relation to the Z140 standard (EN 10346:2015). The solid red line marks the nominal Z140 value of 10  $\mu\text{m}$ , while the dashed red lines represent the standard range of 7–15  $\mu\text{m}$ . Most specimens fall within or above this range. Notably, Series III (strip) significantly exceeds the upper limit (21.4  $\mu\text{m}$ ), suggesting potential overcoating. In contrast, the CFS 30  $\times$  50  $\times$  (1.48–1.5) mm profile shows the lowest average zinc coating thickness (8.6  $\mu\text{m}$ ), still within the standard interval but below the nominal reference. The figure visually highlights these deviations and confirms overall compliance with the Z140 specification.

**Figure 9.** Average zinc coating thickness for each tested series of specimens.

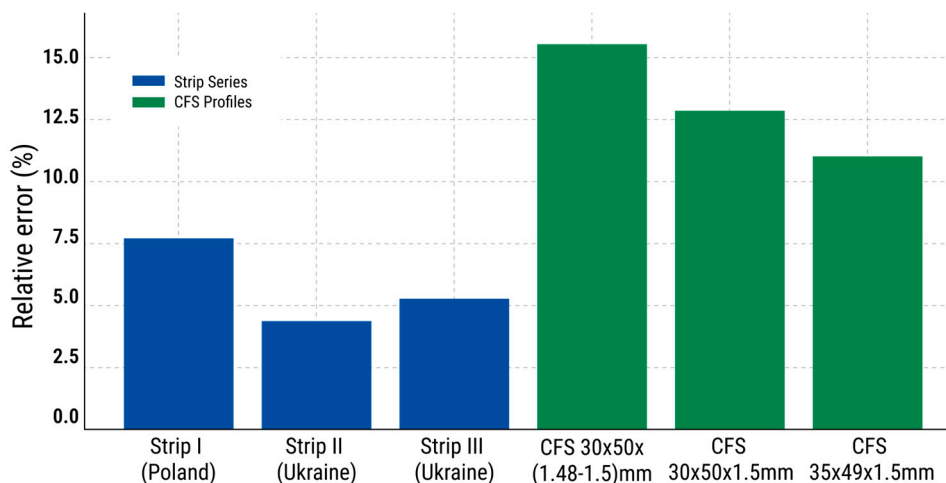
To visualize coating uniformity, Figure 10 shows the relative errors of each specimen series. The highest inhomogeneity was observed in CFS 30  $\times$  50  $\times$  (1.48–1.5), with a relative error of 15.6%, while the most stable coating was achieved in Series II (4.4%). Higher values indicate potential risks to protective performance.

**Figure 10.** Relative error (%) in zinc coating thickness for each specimen series.

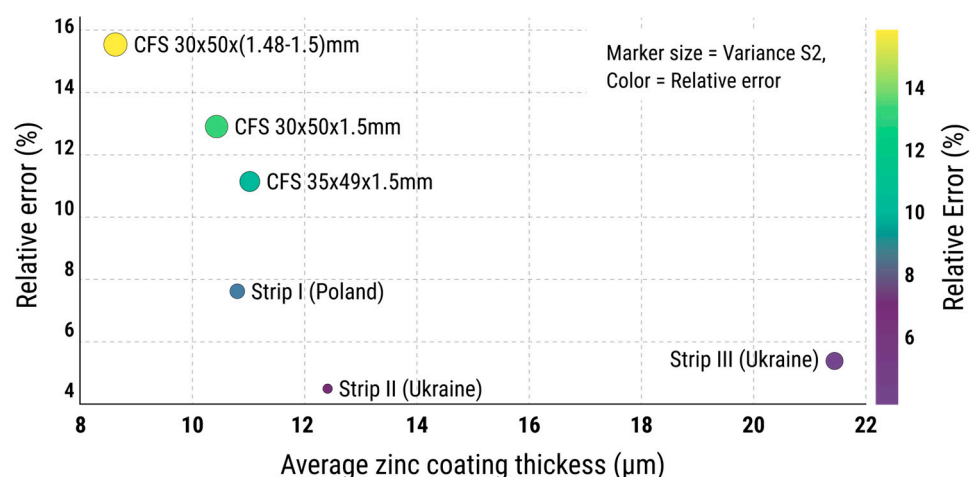
Finally, a bubble chart (Figure 11) was used to compare the zinc coating thickness, variability, and uniformity simultaneously. The chart plots the average zinc coating thickness against the relative error, with the bubble size representing coating variance ( $S^2$ ). The CFS with dimensions 30  $\times$  50  $\times$  (1.48–1.5) mm again stood out as the most vulnerable, exhibiting low average zinc coating thickness, high variability, and significant dispersion—a combination indicative of inconsistent coating quality.

**Figure 11.** Bubble chart showing correlation between average zinc coating thickness and relative error. Bubble size is proportional to variance ( $S^2$ ), reflecting the stability of the coating process relative error (%) in zinc coating thickness for each specimen series.

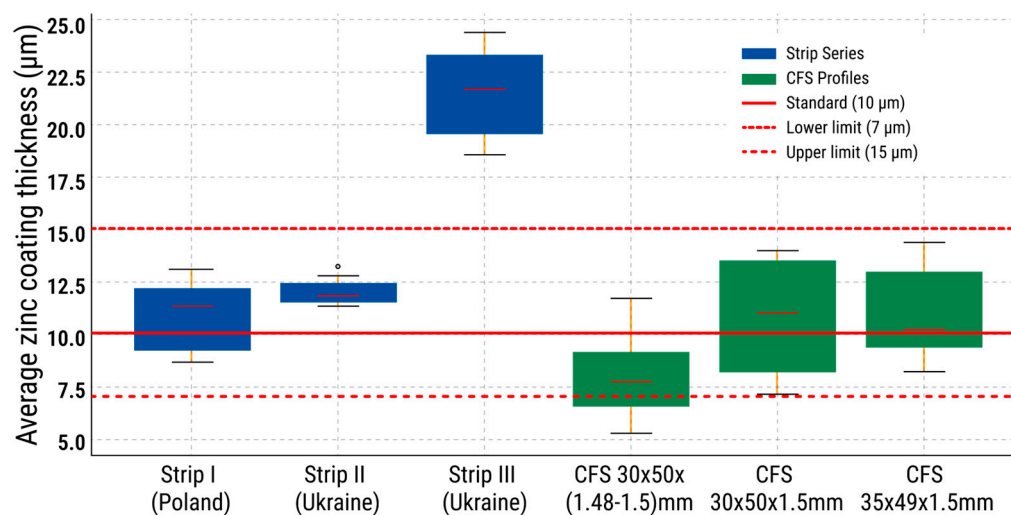
A boxplot diagram (Figure 12) was constructed to illustrate the zinc coating thickness for three strip specimens and three CFS specimens. Series I ( $10.8 \pm 2.3 \mu\text{m}$ ) and Series II ( $12.4 \pm 1.5 \mu\text{m}$ ) fully comply with the standard zinc coating thickness range of 7–15  $\mu\text{m}$ . In contrast, Series III ( $21.4 \pm 3.2 \mu\text{m}$ ) exceeds the upper limit, indicating an excessive zinc coating thickness. The CFS series falls within the acceptable range. The lowest values were observed for CFS  $30 \times 50 \times (1.48\text{--}1.5) \text{ mm}$ — $8.6 \pm 3.7 \mu\text{m}$ —although none of the measurements dropped below 7  $\mu\text{m}$ . The other series—CFS  $30 \times 50 \times 1.5 \text{ mm}$  ( $10.4 \pm 3.7 \mu\text{m}$ ) and CFS  $35 \times 49.5 \times 1.5 \text{ mm}$  ( $11 \pm 3.4 \mu\text{m}$ )—also meet the standard, albeit with greater variation. Overall, all specimens except Series III comply with the normative requirements. The results indicate satisfactory coating quality with isolated deviations that require monitoring.

**Figure 12.** Boxplot diagram of mean values and spread of zinc coating thickness for strip and CFS specimens.

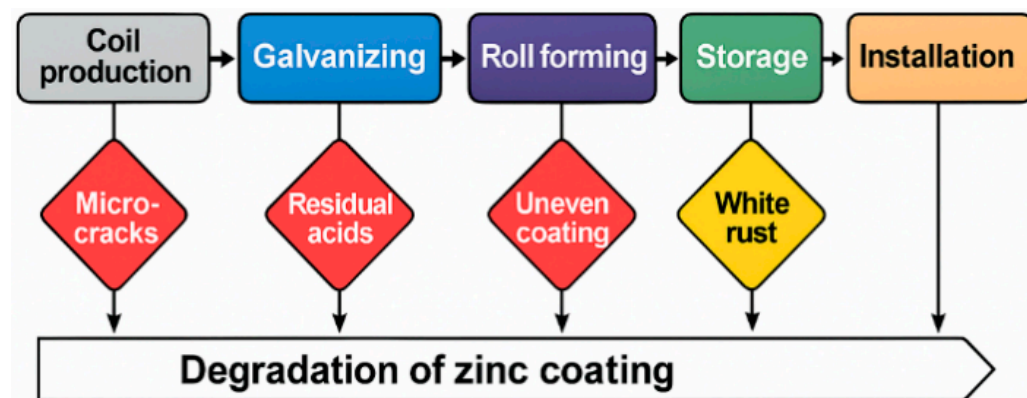
The obtained results indicate that degradation of the zinc coating may begin as early as the coil (strip blank) manufacturing stage, well before the section forming process takes place. This is supported by the presence of five key defects, each with its own origin and potential contribution to reducing the durability of the final product. A schematic representation of zinc coating degradation by production stages is shown in Figure 13.

In particular, non-uniform zinc coating thickness across the strip width, especially in the edge zones, suggests possible disruptions in the cooling process or ineffective operation of the air knives. Local variations in zinc coating thickness may also lead to changes in the relative contribution of individual Zn–Fe sublayers, which differ in their electrochemical behavior and corrosion potential, thereby increasing susceptibility to localized corrosion, as discussed in [46]. These areas most frequently become sites of localized protection loss and corrosion initiation, indicating the need for localized monitoring or adjustments to the drying technology.

Figure 13. Schematic representation of zinc coating degradation by production stages.

Mechanical damage reflects the influence of the rolling mill stands, which may result from uneven strip tension, roll contamination, or poor-quality lubrication. Such microcracks compromise the continuity of the zinc coating, creating conditions for moisture penetration and the formation of galvanic corrosion sites.

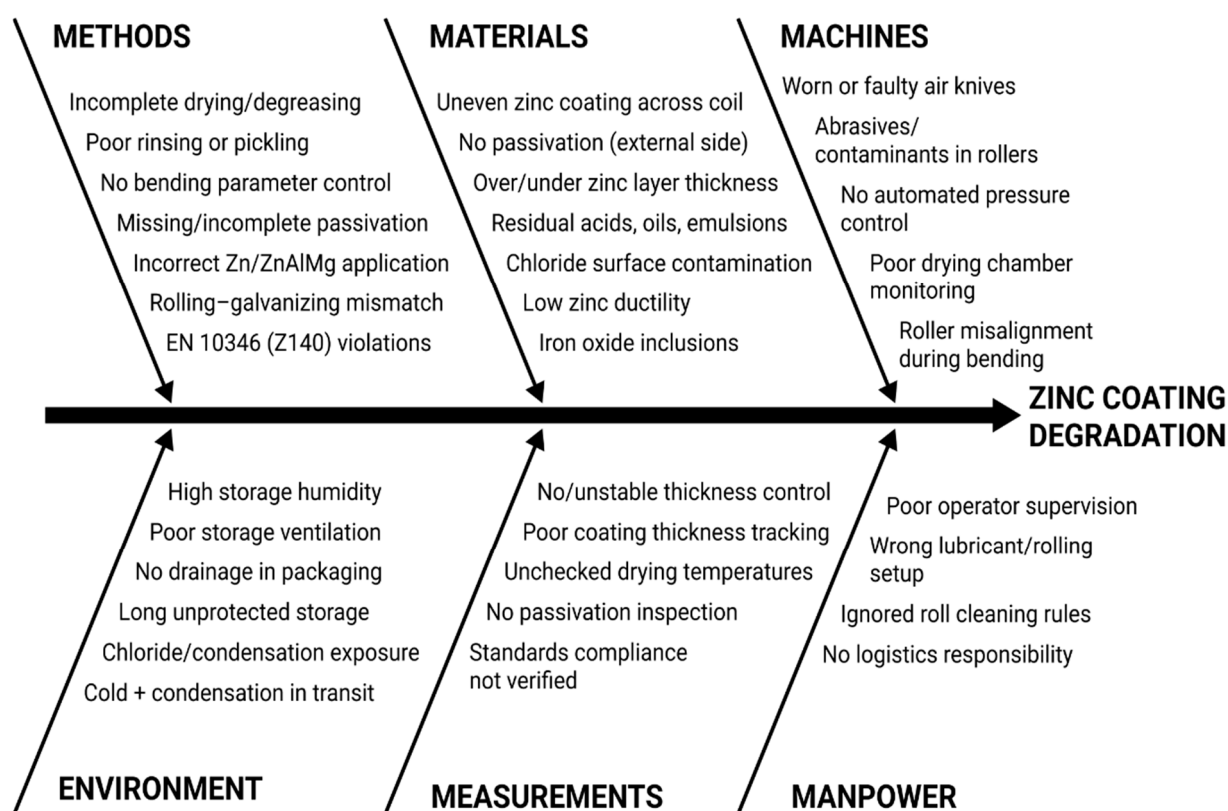
The cause-and-effect structure of these influences is presented in the form of an Ishikawa diagram (Figure 15), which covers six key categories: Equipment, Materials, Methods, Personnel, Measurements, and Environmental Conditions.

Figure 15. Ishikawa cause-and-effect diagram for zinc coating degradation.

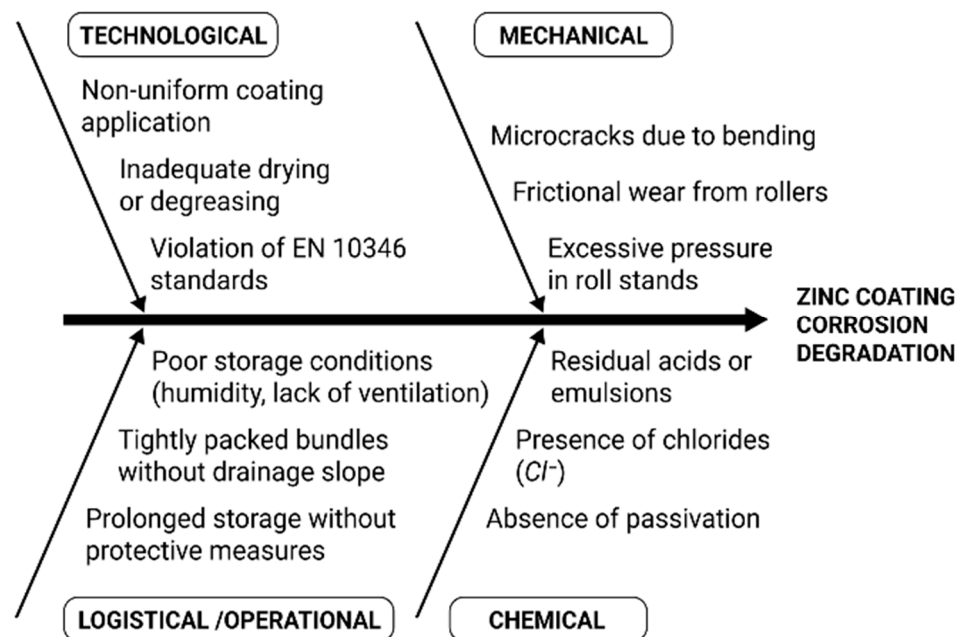
Additionally, to facilitate the analysis of damage types, a classification of influence types was developed based on their nature: mechanical, chemical, technological, and logistical (Figure 16). This allows for the identification not only of the sources but also of the nature of the critical defects observed in the studied specimens. Such an approach provides a foundation for developing a multi-level strategy to enhance coating durability.

**Figure 16.** Systematization of zinc coating impact factors by mechanisms of action.
